# Remote Sensing and GIS Techniques for Selecting a Sustainable Scenario for Lake Koronia, Greece

**Abstract** During recent decades, Lake Koronia has undergone severe degradation as a result of human activities around the lake and throughout the basin. Surface and groundwater abstraction and pollution from agricultural, industrial, and municipal sources are the major sources of degradation. Planning a restoration project was hampered by lack of sufficient data, with gaps evident in both spatial and temporal dimensions. This study emphasized various remote sensing and geographic information system techniques, such as digital image processing and geographic overlay, to fill gaps using satellite imagery and other spatial environmental, hydrological, and hydrogeological data in the process of planning the restoration of Lake Koronia, following Ramsar guidelines. Current and historical remote sensing data were used to assess the current status and level of degradation, set constraints and define the ideotype for the restoration, and, finally, define and select the best restoration scenario.

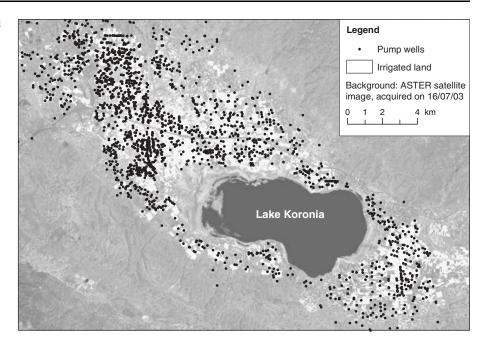
**Fig. 1** Spatial distribution of irrigated fields and locations of pump wells

The land-cover type "irrigated area" constituted a different thematic map because it was considered the source of highest environmental pressure on the lake. A further comparison of the area mapped with that of irrigated land reported by local authorities was not significantly different. A separate thematic map was created that displayed the spatial distribution of irrigated fields and the location of the 2500 pump wells. Figure 1 gives a qualitative assessment of both the pumping impact on the aquifer and the source of agricultural pollution.

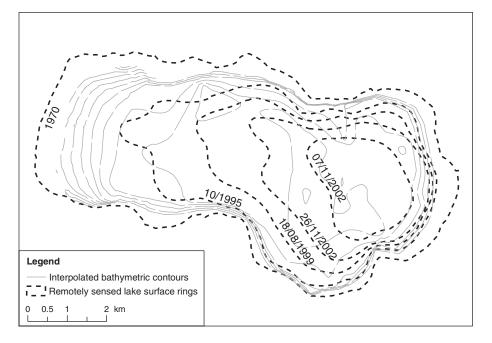
Fig. 2 Interpolated contours of Lake Koronia bathymetry versus shoreline "rings" derived from remote sensing (after Pittas 2003)

Global Positioning System for horizontal determination and classical geodetic methodology using a surveying rod for depth determination. Bathymetric contours were interpolated to a continuous surface using the ANUDEM algorithm (Hutchinson 1989). This interpolation process was selected because it performs well even with relatively small input datasets and uses a roughness penalty parameter that can be modified to allow the fitted surface to follow the smooth changes of the lake bottom. Visual examination of the original measured points with the bottom surface produced no discrepancies. Further comparison revealed a mean difference of 0.02 m (t = 2.268, df = 258, P = 0.024).

These data were considered current, as no drastic changes in the lake bottom were recorded, and this was verified by actual measurements taken at 20 locations. An additional check was performed using a time series of satellite images that covered the time when the water level dropped from 6 m to less than 1 m. Mapping of lake shoreline "rings" was used as a means of establishing bathymetric contours at certain depths. Remote sensing is an excellent means of mapping aquatic boundaries, with accuracy approaching 90% (White and others 1993). This work, as described in detail by Pittas (2003), employed an ISODATA classification algorithm to characterize the lake in a time series of archived Landsat MSS, TM, and ETM+ satellite images from 1995 to 2002, with spatial resolution ranging from 79 to 30 m. The "rings" of the shoreline where compared visually with the interpolated bathymetric contours (Fig. 2). A statistical comparison was also implemented to identify the similarity of the two datasets. Sampling was conducted at 1-km intervals along the shoreline "rings." The elevation recorded on the shoreline "rings" was compared with the elevation of the interpolated lake bottom, revealing a mean difference of 0.11 m (t=1.719, df=57, P=0.091). Differences were attributed to the alternate methodology and source of data: one being the result of satellite digital image processing and the other being interpolated surveyed data.

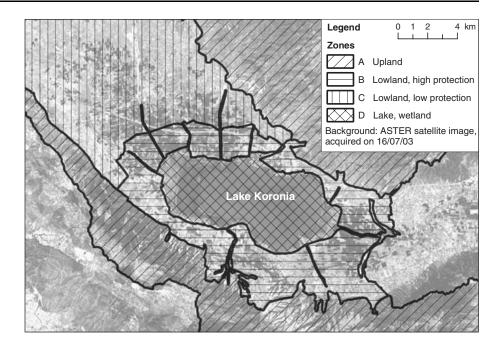
**Fig. 3** ZSFI identified in the study area

The functional assessment was facilitated by division of the watershed into Zones of Specific Functional Interest (ZSFI). In each zone, several functions are performed (e.g., groundwater recharge, foodweb support), but some are more important than others, depending on the "ecological" role of the zone in the watershed and the management priorities for the area (e.g., agricultural production or nature conservation). Also, different driving forces, which lead to pressures, are prominent in each zone (intensive agriculture, industrial activity, livestock). Topography also defines the selection of zones, as there are different functions of interest in the wetland than in the upper catchment. Protection zones that apply were considered as well because they pose a different level of restriction. Delineation of the ZSFI was therefore based on the spatial distribution of the following parameters: hydrology-geomorphology (which separates important functions and defines topography), land cover-land use (which separates driving forces that lead to pressures), and protection status. Using the appropriate geographic layers (large geomorphic units, DEM, land cover, and protection zones) in a GIS and performing overlay analysis with a set of criteria (relational and Boolean functions), polygons were derived that provided a synthesis of the above-mentioned parameters. Computer-assisted photo-interpretation of the satellite image was used both to correct errors due to misregistration of the geographic layers and to eliminate small polygons with no physical meaning. The resulting polygons, after being grouped according to similar characteristics, formed the ZSFI (Fig. 3). Four ZSFI zones were delineated: (A) upland, (B) lowland-high protection, (C) lowland-low protection, and (D) lakewetland.

Functional evaluation of the ZSFI revealed that natural processes in Zone A (upland) were responsible for large volumes of sediments entering the lake. The main transporters of these are streams with permanent and seasonal flow. As a result, water quality is degraded, and in the long term, water storage capacity of the lake is reduced. In Zone B and Zone C (lowland), agriculture was responsible for surface and groundwater pollution via agrochemicals (N, P, K), whereas industry and urban expansion were responsible for degradation of surface water quality due to discharge of large amounts of salts, nutrients, heavy metals, and toxic elements. Overexploitation of surface water and groundwater for industrial, municipal, and mainly agricultural use was responsible for modification of the water budget. The negative water budget of recent years (1982-2002) lowered the water table and increased the hydraulic slope from the streams to the water table. Eventually, groundwater discharge to the lake was minimized. In Zone D (lake-wetland), dense vegetation, mild slopes, and the location of the wetland on the west side had a positive contribution via interception of floodwater. Fish populations decreased in the 1980s and completely vanished in 1997. The conditions of habitat types in the lake-wetland are heavily or mildly degraded, and together with the high level of nuisance caused by human presence, birds and mammals populations have decreased. Overall, the

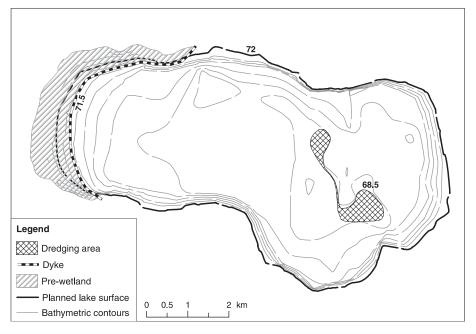
Fig. 4 Best scenario for restoration of Lake Koronia. Elevations are meters above mean sea level

Following Ramsar guidelines and the functional evaluation described, the most appropriate solution for restoring Lake Koronia was selected, which includes lake dredging, water-level enhancement, and wetland creation (Fig. 4). The water level of the lake would be raised by 0.5 m and a wetland would be created at the western end of the lake at contour 71.5 m, defined by a dike. In addition, 117 ha of the lake bottom would be dredged by 0.5 m to increase lake depth and create deep-water habitat. Dredged material would be used to create the dike using the Confined Disposal technique (USACE 1987). The lake would cover 3500 ha, with a maximum water volume of  $83.8 \cdot 10^6$  m<sup>3</sup>. The maximum water depth of the lake would be 4 m. Control of water level and recycling of water would be achieved through hydraulic modification of the ditch connecting lakes Koronia and Volvi.

This scenario maximizes both vertical and horizontal aspects of lake management. The constructed dike will manage water levels in a wetland to the west, with open-water areas embedded within a highly vegetated marsh. It will also increase the depth of the lake selectively to provide a refuge for fish during a drought.
