Evidence and implications of extensive groundwater overdraft-induced land subsidence in Greece

E. K. Paleologos¹ and S. P. Mertikas²

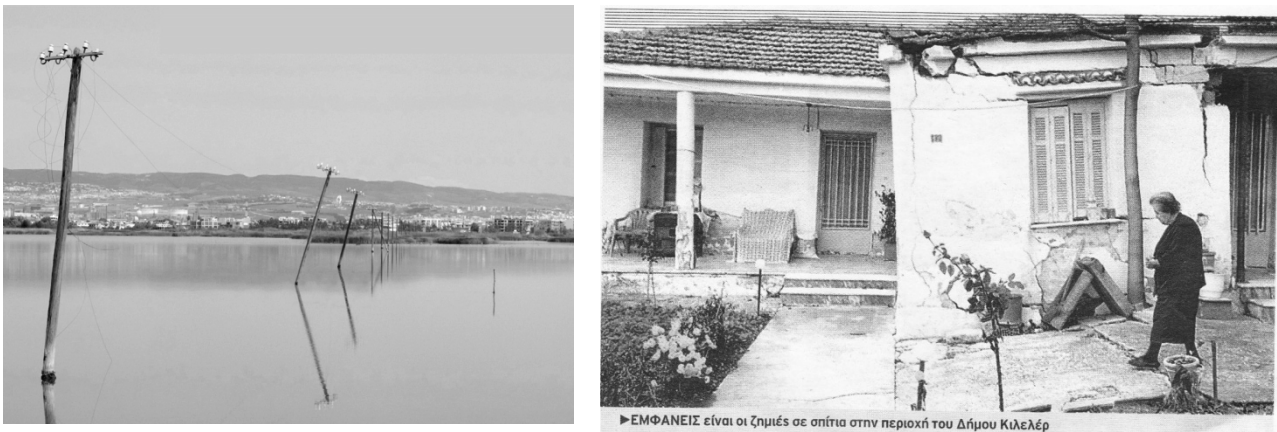
Figure 1. Left: Submerged electricity poles at the Kalochori area, Greece (Mouratidis et al., 2009). Right: Land subsidence in Thessaly, Greece (newspaper "Ethnos, January 31, 2012).

In northern Greece the Kalochori (Figures 1 and 2), a western suburb of the city of Thessaloniki, has subsided at a rate of up to 13 cm/year until the early 2000, the rate being reduced to about 5 cm/year recently (Mouratidis et al., 2009). The total subsidence based on historical leveling and recent GPS data is about 3.5m, and land up to 2km inland has been submerged under the sea (Stiros, 2001; Psimoulis et al., 2007). The area constitutes a tectonic graben with Quaternary and Neogene deposits of depth up to 700m, and is located on the 2,500 year old deltaic sediments of four main rivers. The hydrostratigraphy of the area consists of the following: from the surface to a maximum depth of 15m there exists a layer of yellow-brown fine- to medium-grained sand and silty sand, defining a shallow unconfined aquifer; subsequently, and to a maximum depth of 35m a layer of black-grey silty sand and organic material acts as an aquitard between the unconfined and the deeper confined aquifers. The confined aquifers consist of alternating layers of brown medium to coarse-grained sands and black-grey silty sands and clays, with the layers' thickness varying from 5m to 50m. Since 1955 the confined aquifers were used for groundwater extraction (a total of about 500 deep drill-wells extending to depths of 200m) for industrial purposes and the needs of the Thessaloniki metropolitan area, at a rate of 1600-1900 m³/hr during the period of 1958-1963. Thus, the piezometric surface that in the 1950s was above ground surface fell, due to deep drilling, by 37m in 1981, and partially recovered (varying between 20m to 30m) by 2000 because of the cessation of the non-industrial wells (Loupasakis and Rozos, 2009).

Land subsidence became noticeable in the 1960s with marine invasion and flooding first appearing in 1964. The fact that the uniform subsidence that has occurred is localized to the Kalochori-Sindos area excludes regional scale tectonic effects as the cause of the phenomenon. Subsidence is considered to have been caused mainly by consolidation, i.e. compaction of the

confined aquifers and drainage of the highly compressible black silty clays, and secondarily by the oxidation of the near surface peat soils and the shifting of the deltaic mud that resulted from the deep layers' consolidation (Loupasakis and Rozos, 2009). Pumping was drastically reduced in the 1980s, but despite the partial recovery of the piezometric surface no significant land rebounding has been reported.

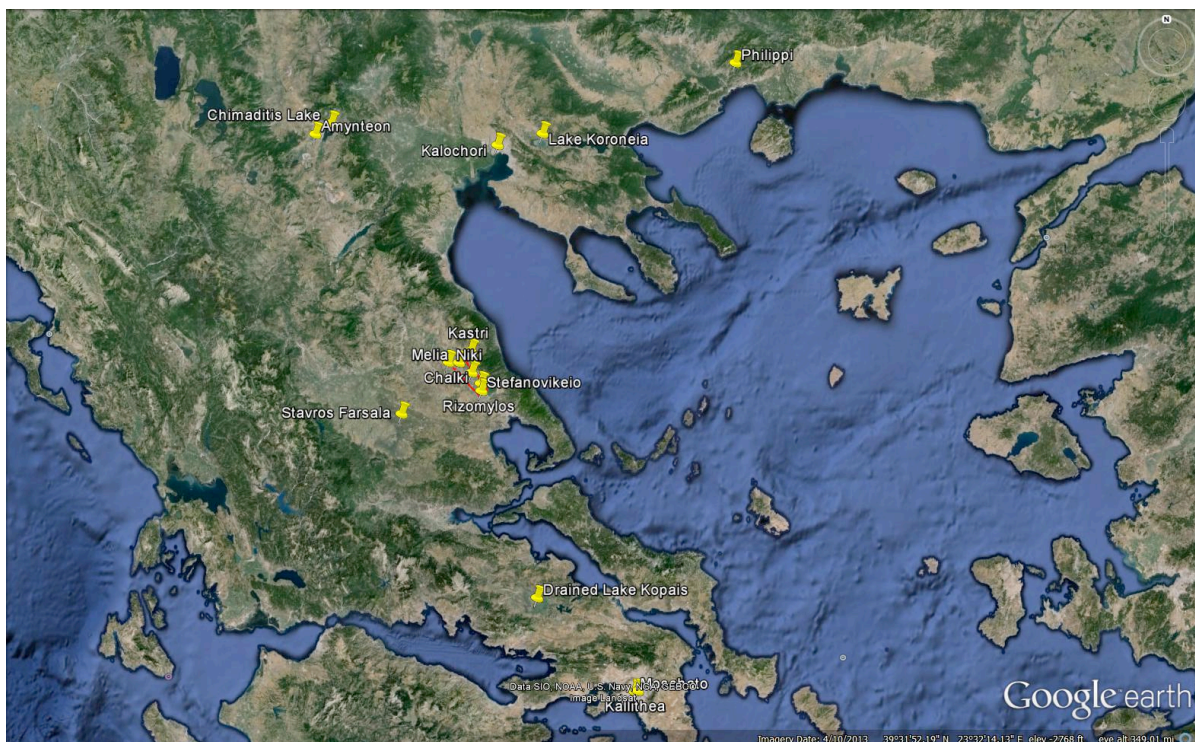
Figure 2. Reported water-overdraft-and-drainage induced subsidence locations, mainland Greece (Google Earth image).

Drainage of the extensive wetlands of Greece was undertaken from about the 1920s to 1960 for control of malaria and flooding, and to increase the cultivated land in order to accommodate the influx of one and a half million Greeks from Asia Minor in 1923 (Sivignon, 2007). Natural wetlands, where the water table is slightly under, or at the ground surface are net carbon sinks because the rate of organic accumulation at the anaerobic bottoms dominates organic decomposition. The creation of aerobic conditions upon drainage of a wetland or a permanent drop of the water table turns a wetland into a carbon source by accelerating microbial decomposition and loss of soil carbon as gaseous CO₂ (Deverel and Rojstaczer, 1996). Land subsidence due to peat oxidation and self-ignition in drained wetlands has occurred in Philippi (Figure 2) at the prefecture of eastern Macedonia; at the Chimaditis Lake (Figure 2) at the prefecture of western Macedonia; and at Lake Kopais (Figure 2) at the prefecture of Boeotia, south-central Greece.

Conditions of consolidation exist also in Lake Koroneia (Figure 2), which is found 12 km north-northeast of Thessaloniki. From close to the surface to a depth of about 50 m a shallow phreatic aquifer exists, followed by very low permeability black clay layers extending from a depth of 50 m to 80 m, indicating the existence of lake deposits. Shallow aquifers are exploited for irrigation purposes by at least 2,000 wells. Deep confined aquifers are found below the clay zone to a depth of 450m, and are also exploited by approximately 500 wells. Although past studies had assumed no connection between shallow and deep aquifers (with clay layers considered as impermeable layers separating deep confined and shallow unconfined aquifers) borehole drillings in the late 1990s revealed the existence of red discontinuous clays indicating a hydraulic connection between deep and shallow aquifers. The total mean aquifer drawdown rate in the lake's sub-basin during 1971-1996 was 0.2m/yr, doubling (0.5m/yr) during a 5-year period (1997-2001) as a result of the intensification of pumping (Mylopoulos et al., 2007). The existence of the 30 m thick clay layer and the intense exploitation of the groundwater resources, which has practically eliminated the lake, are preconditions for disruption of the water pressure balance between the aquifer and the clay formations, and for drainage of the clay. Since no subsidence incidents have been reported up to now the clay may still be at a pre-consolidation stage, in which case the situation may be reversible with the planned lake-aquifer replenishment projects.

Anthropogenic-induced land subsidence in Thessaly was first observed in the late 1980s with surface soil ruptures and since then with damages to buildings, roads, and public infrastructure projects in several towns (Figure 2: Chalki, Melia, Stefanovikeio, Rizomylos, Niki, Kastri, Stavros) (Ntakoulas et al., 2004; Kontogianni et al., 2007; Sideri et al., 2012). In the drained Karla Lake area the subsidence has been exacerbated by the 1962 lake's drainage (drained area 180km², approximately) and elimination of its contribution to the aquifer's natural replenishment (Gerakis, 1992). Despite the existence of two faults in the vicinity of the drained Karla Lake the magnitude of subsidence at surrounding locations cannot be explained by deep tectonic effects and fault creep, which appear to have a small effect (<1mm/yr), and subsidence appears to have resulted, primarily, from consolidation and karstic dissolution following ground water over-exploitation (Kontogianni et al., 2007). Persistent Scattering Interferometry and DInSAR studies of the period 1992-2006 and 1992-2010, respectively, indicate a maximum subsidence rate of 25mm/yr north and east of the city of Larissa, with the remaining plain subsiding at 5-10 mm/yr, and insignificant deformation changes

In the broader Piraeus-Athens area subsidence has been observed since the early 1960s predominantly at the coastal suburbs of Faliro, Moschato, and Kallithea (Figure 2) (Georgopoulos and Teleioni, 2010), along the loose alluvial deposits of Ilissos and Kifisos Rivers with maximum total subsidence of about 12 cm. The geology of these suburbs at depths of about 10m is characterized by clay layers with width between 2 to 5m, and to a depth of 30m by silt, sand and clayey sands. At locations where subsidence has been observed the water table was measured during 1996-97 to lie 10 m below the elevation of the sea. Parcharidis et al. (2006) based on 264 differential interferograms, and excluding co-seismic deformation from the 1999 Athens earthquake, reported for the period 1992-2002 a total subsidence of 12mm in the southern and about 40mm in the northern suburbs of Athens, respectively. Subsidence exists also for parts of the city center, but was associated with recent underground construction activities for the Athens subway system. In general, land subsidence in Athens is attributed to mining activities, major underground construction projects, large magnitude earthquakes, river modifications, and groundwater over-exploitation. Drilling-well distribution exhibits good correlation with the deformation patterns in the southern and the northern suburbs. Thus, land subsidence in these areas, is thought to result from groundwater withdrawal, with aquifer compaction and clay compressibility constituting the dominant subsidence mechanism (Parcharidis et al., 2006).

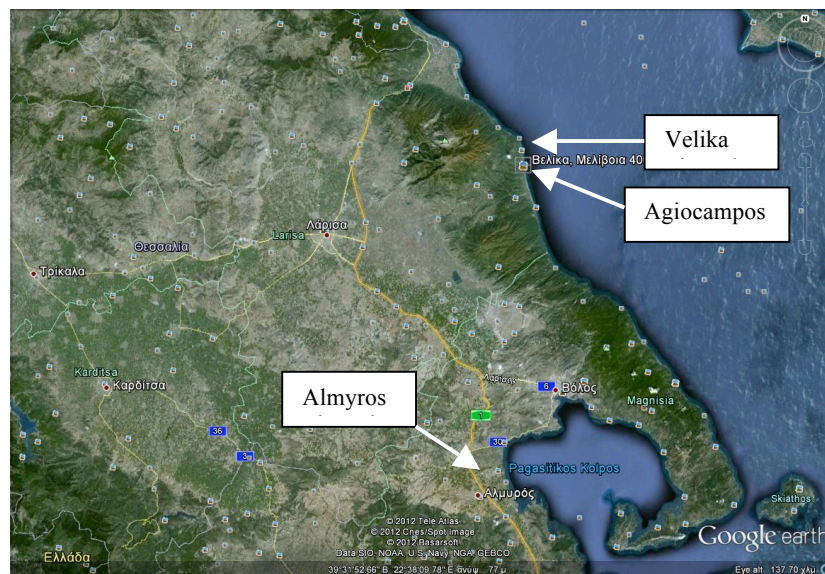
Figure 4. Thessaly and locations of salt-water intrusion (Google Earth image).

In Thessaly, where the water table is estimated to drop by 5 m every year, at several coastal locations, along the Velika-Agiocampos coastal line and at Almyros (Figure 4), where fractured carbonate formations are encountered, severe salt water intrusion problems have appeared. Similar problems exist in coastal locations in Athens where the water table was found in 1996-97 to lie 10 m below the elevation of the sea. Similarly, salt water intrusion problems were detected at the northwestern part of the Messara plain, the Tymbaki basin, by transient electromagnetic, vertical electrical soundings, and radio-magnetotellurics surveys (Pipatpan and Blindow, 2005).
